Piattaforme Aeree Semoventi / Self-Propelled Aerial Platforms

Subject: Verification campaign on SG1100-JE – SG1400-J – SG1600-J – A13 JE – A16 J – A18 J

Construction year: from 2006 to 2012

Serial numbers: from SG0605216 to SG224407

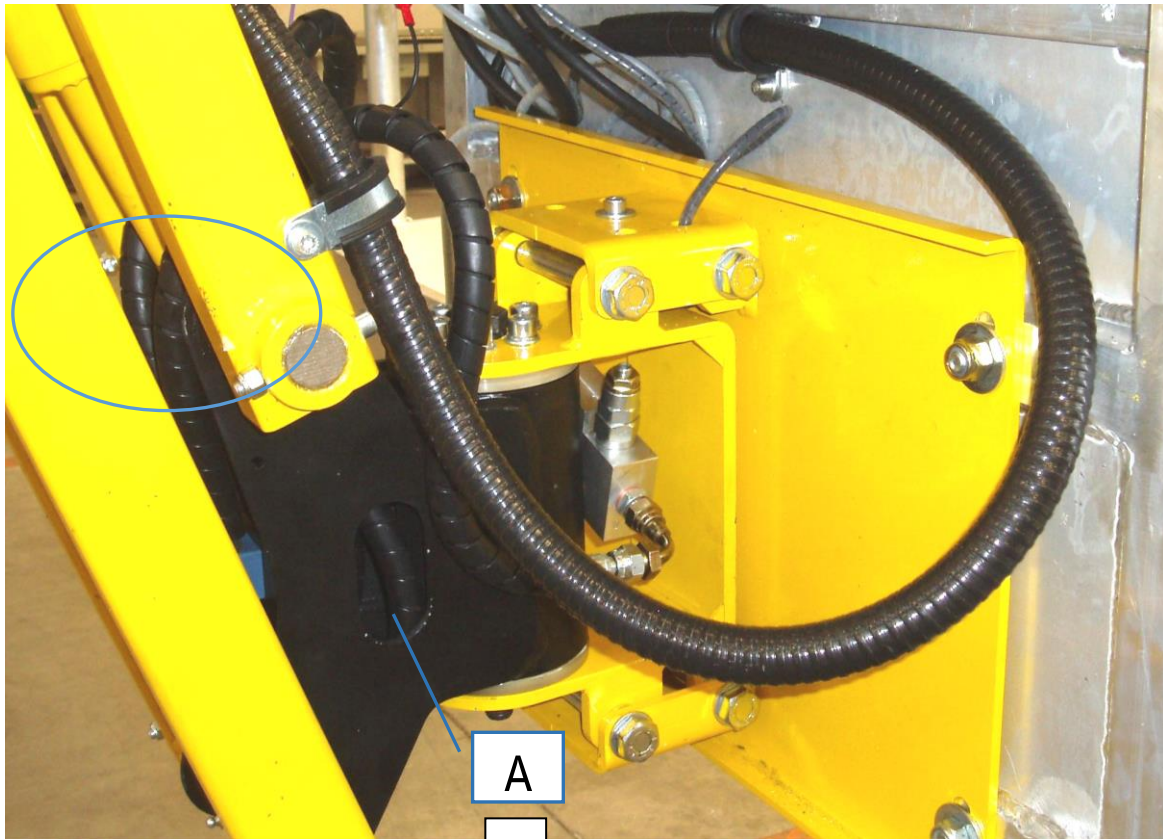
Locate the FLANGED ROTARY ACTUATOR component indicated by the letter "A" in the image below.

Clean the highlighted areas (in particular the weld joints) from any residual grease, dirt and everything that could impede a correct inspection of the area.

Check the highlighted areas (especially the weld joints): there must be no fractures or cracks.

Although the pre-operational visual verification of the structure is already foreseen among the legal obligations, it is recommended to the person in charge (user, owner, grantor, renter and other) to verify with the utmost promptness the particular mentioned according to the instructions that follow, and to put the machine out of service in case of doubts or fractures of which some examples are shown below.

If there are no obvious defects it is possible to continue working with the machine, but it is underlined the need to have the pre-operative visual check carried out scrupulously (as foreseen by the instruction manual and the technical standards in force) whenever you intend to use the machine, by the "Operator".
